Check for Chafed Cables

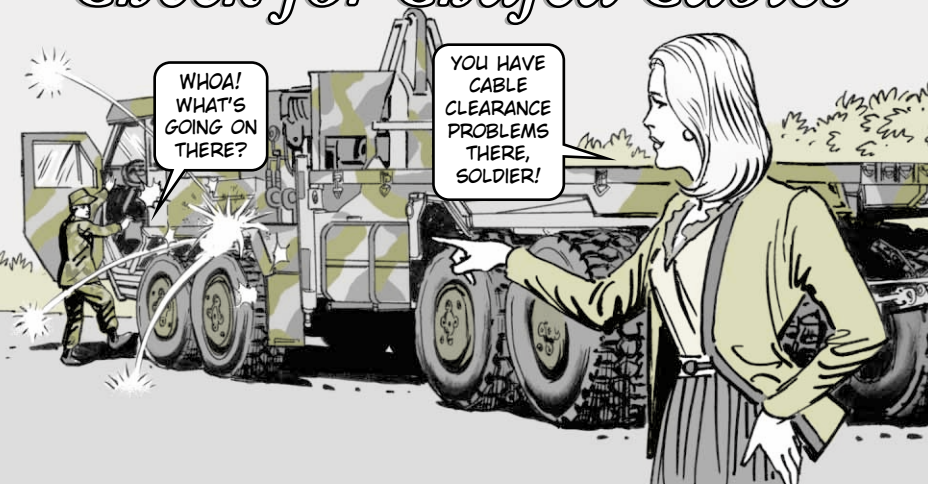
If your PLS tractor has a 200-amp alternator, take time to eyeball where the battery disconnect cable goes under the engine access panel.

Some alternators were installed in the field using instructions that didn't call for cutting or bending the corner of the access panel to allow enough clearance for routing the cable. So many of the cables are chafing and shorting out on the panel.

Other 200-amp alternators were installed on the assembly line. They have a modified access panel that doesn't chafe the cable.

If any of your PLS tractors have cable clearance problems, bend or cut the panel to provide about 1 inch of space between the panel and the wire.
